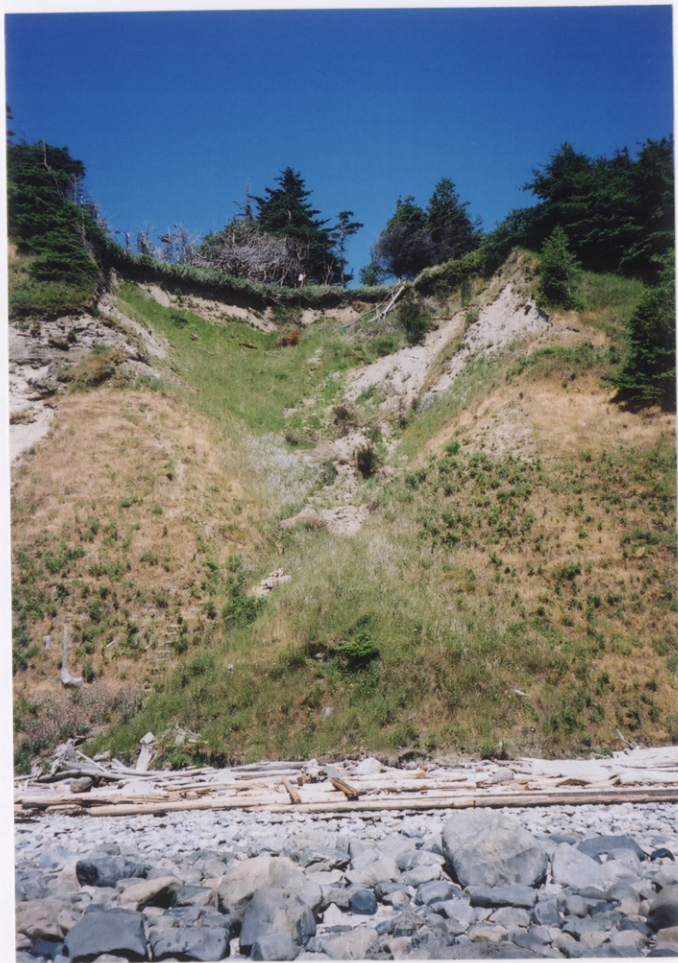
Photo 3 - Looking north at a gully on the south shore near the end of Sutherland Road. A recent slide has taken place, initiating on the east side of the gully head. Slide debris from past events has built up a debris cone at the base of the slope.
