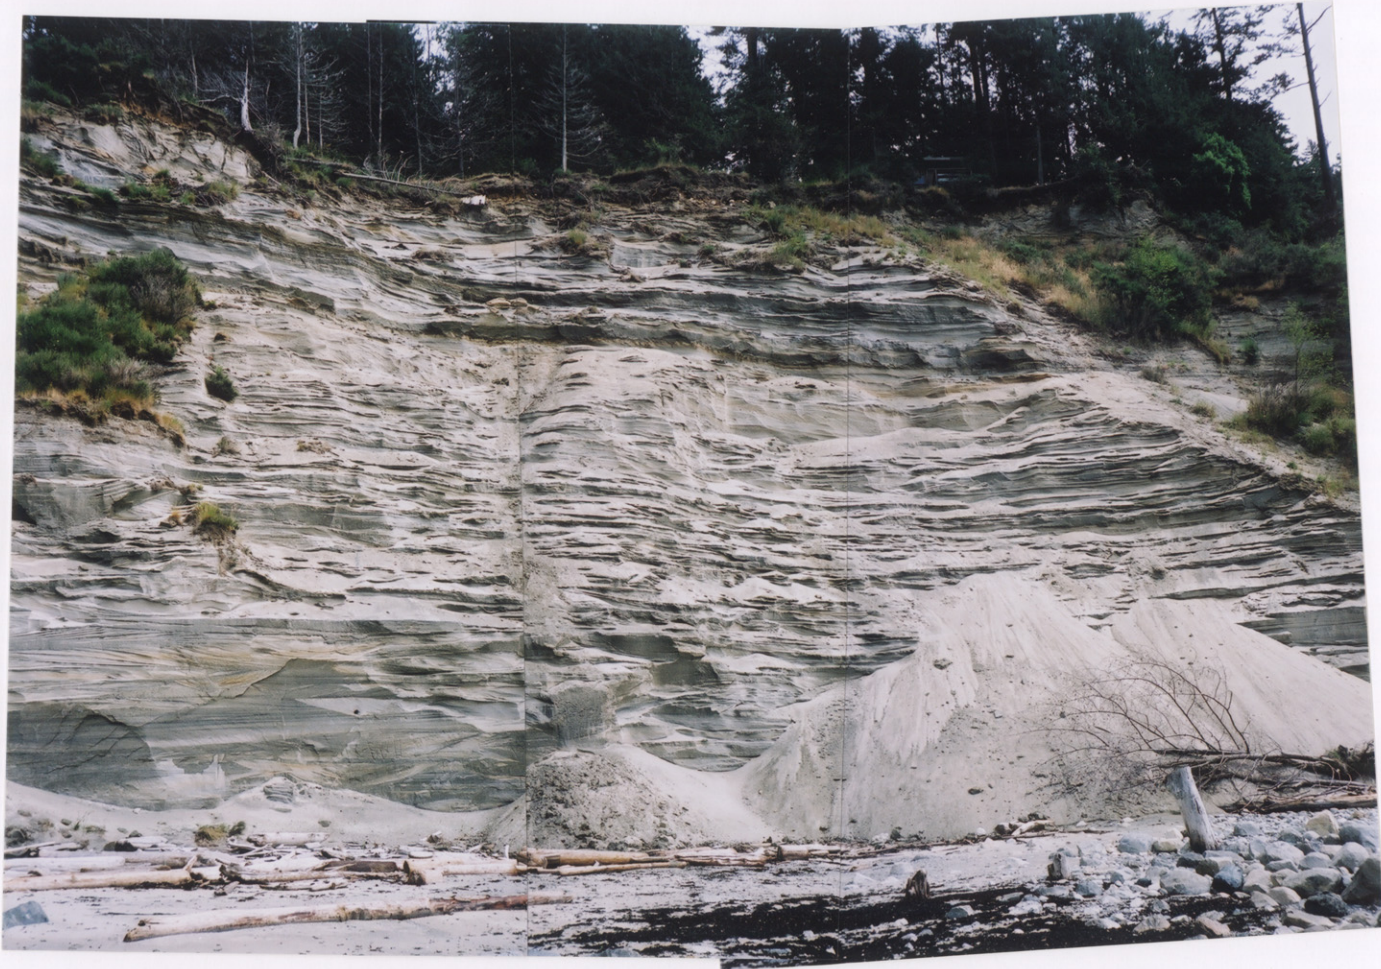
Photo 4 - Looking north at the erosion face in Quadra Sand on the west side of Garnet Point. Eroded sand accumulates at the base of the slope and is removed by wave action. Intense erosion here is ascribed to refracted storm waves from the southeast. The Geological Survey of Canada measured 0.38 m of bluff crest retreat in 1 year at this location.
